Center Hill Dam Consensus Report External Peer Review

August 30, 2007

External Peer Review Panel

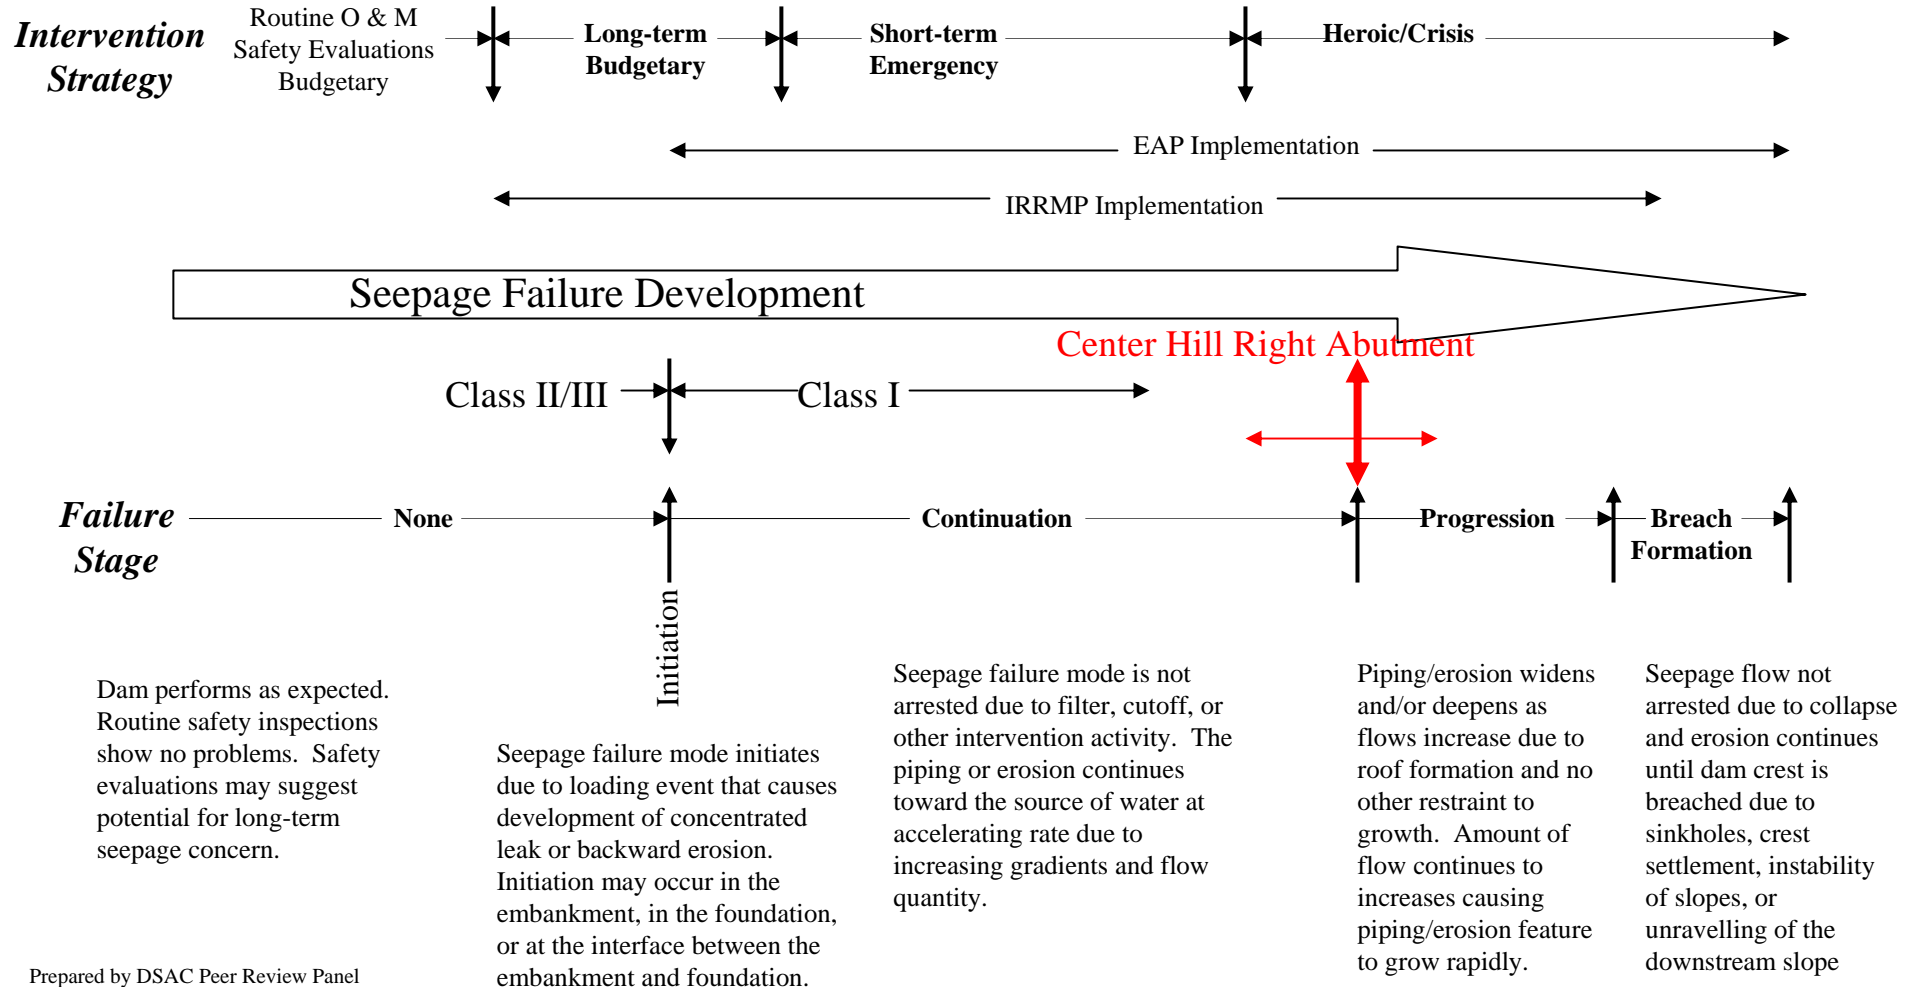
Estimated Condition for Center Hill Dam Right Abutment

Short-term intervention may include:
Modified operations
Reservoir drawdown
Reservoir restrictions
Grouting
Filter/drains/berms
Relief wells

Heroic/Crisis intervention may include:
Emergency drawdown
Evacuation of downstream residents
Filters
Downstream gradient reduction
Crack or pipe filling
